Manhole Inspection Summary

Manhole # S25WW_013MH

Insp Date: **7/9/08 1:06 PM**

Location Address: **3201 CLIPPERMILL RD**

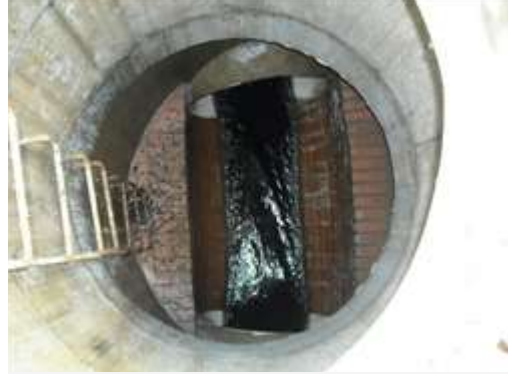
Top View

Bench debris.

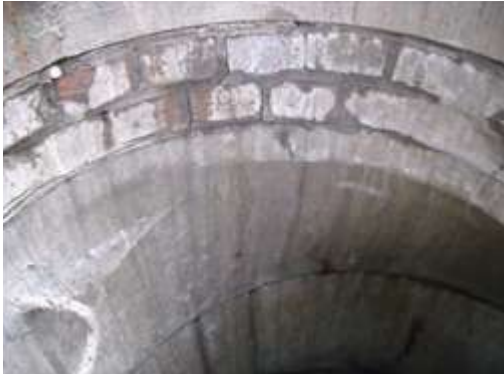
Defect

Frame leaks. Adjustment and Corbel infiltration.

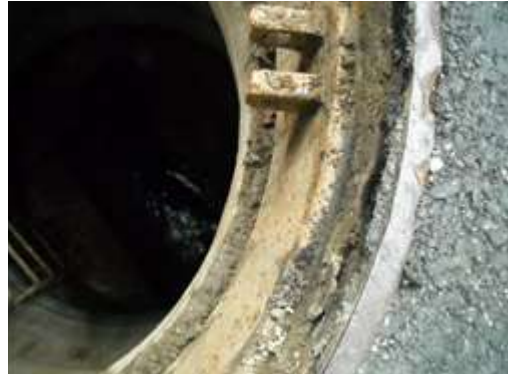
Defect

Frame leaks. Frame offset. Adjustment infiltration.

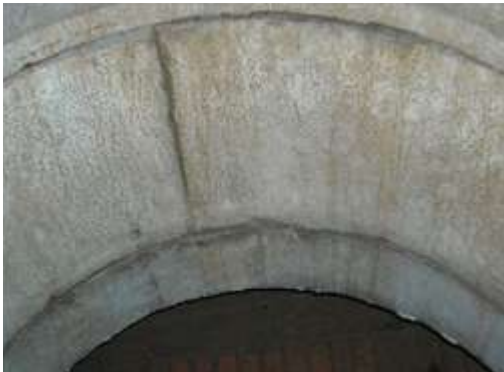
Defect

Corbel and Barrel infiltration.

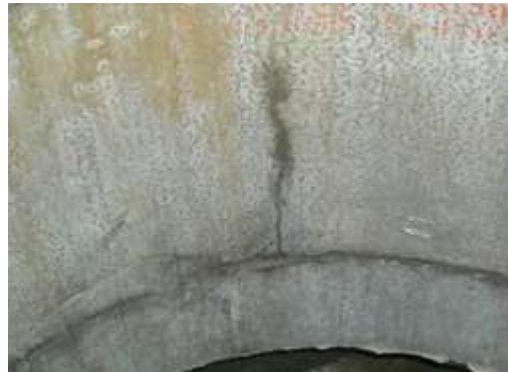
Defect

Barrel crack and infiltration.

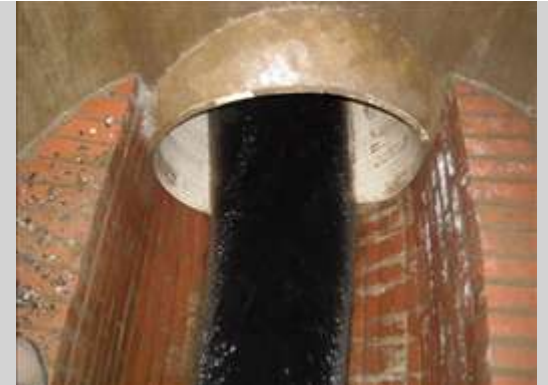
36 in. Circular Gravity Sewer Pipe Out @ 12 O'Clock

Infiltration: **None** Pipe Seal Cond: **Unknown**

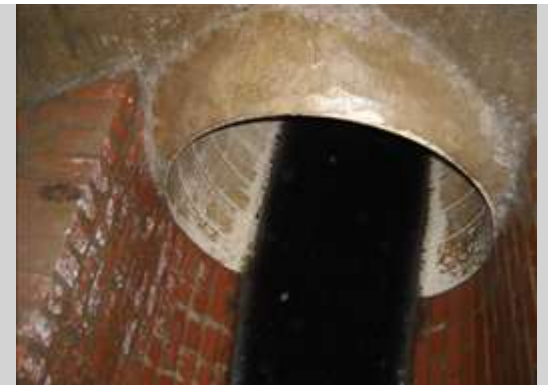
36 in. Circular Gravity Sewer Pipe In @ 7 O'Clock

Infiltration: **None** Pipe Seal Cond: **Unknown**
